Documentation  
of Wall Painting

## Our service for you

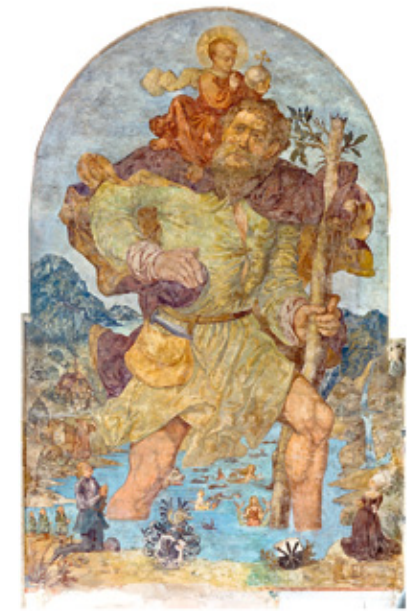
**Creglingen, Herrgottskirche,  
Christophorus fresco**  
Large-scale documentation and  
UV-fluorescence images, 2010.

▲ Photomap 1:10.

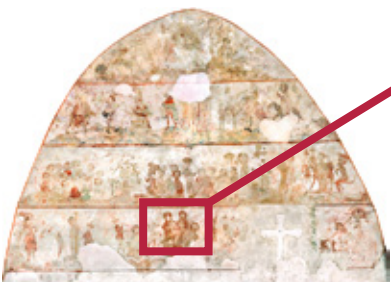
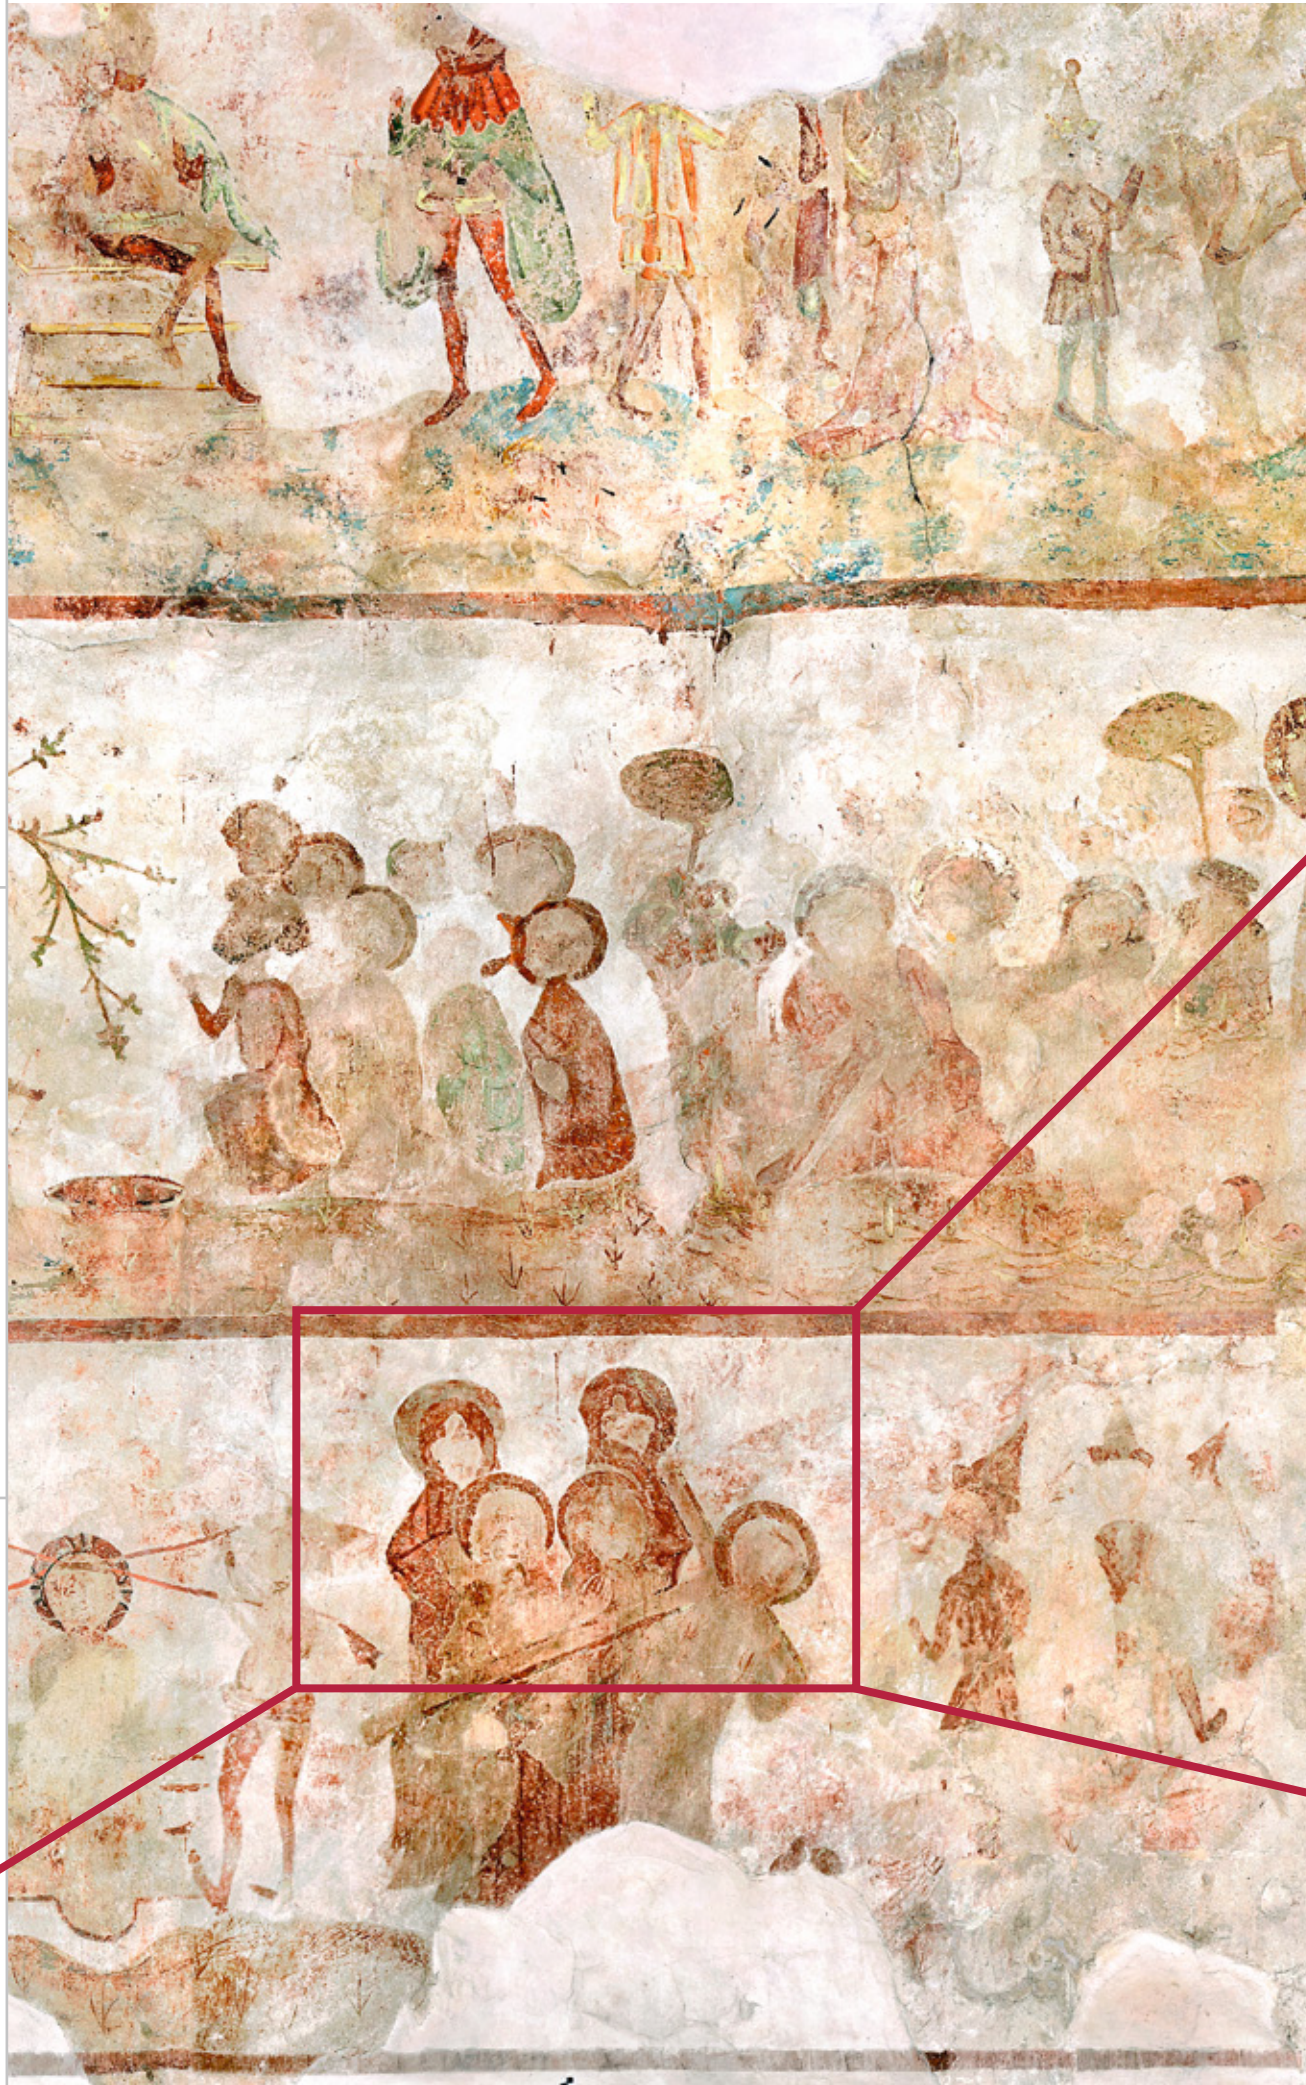
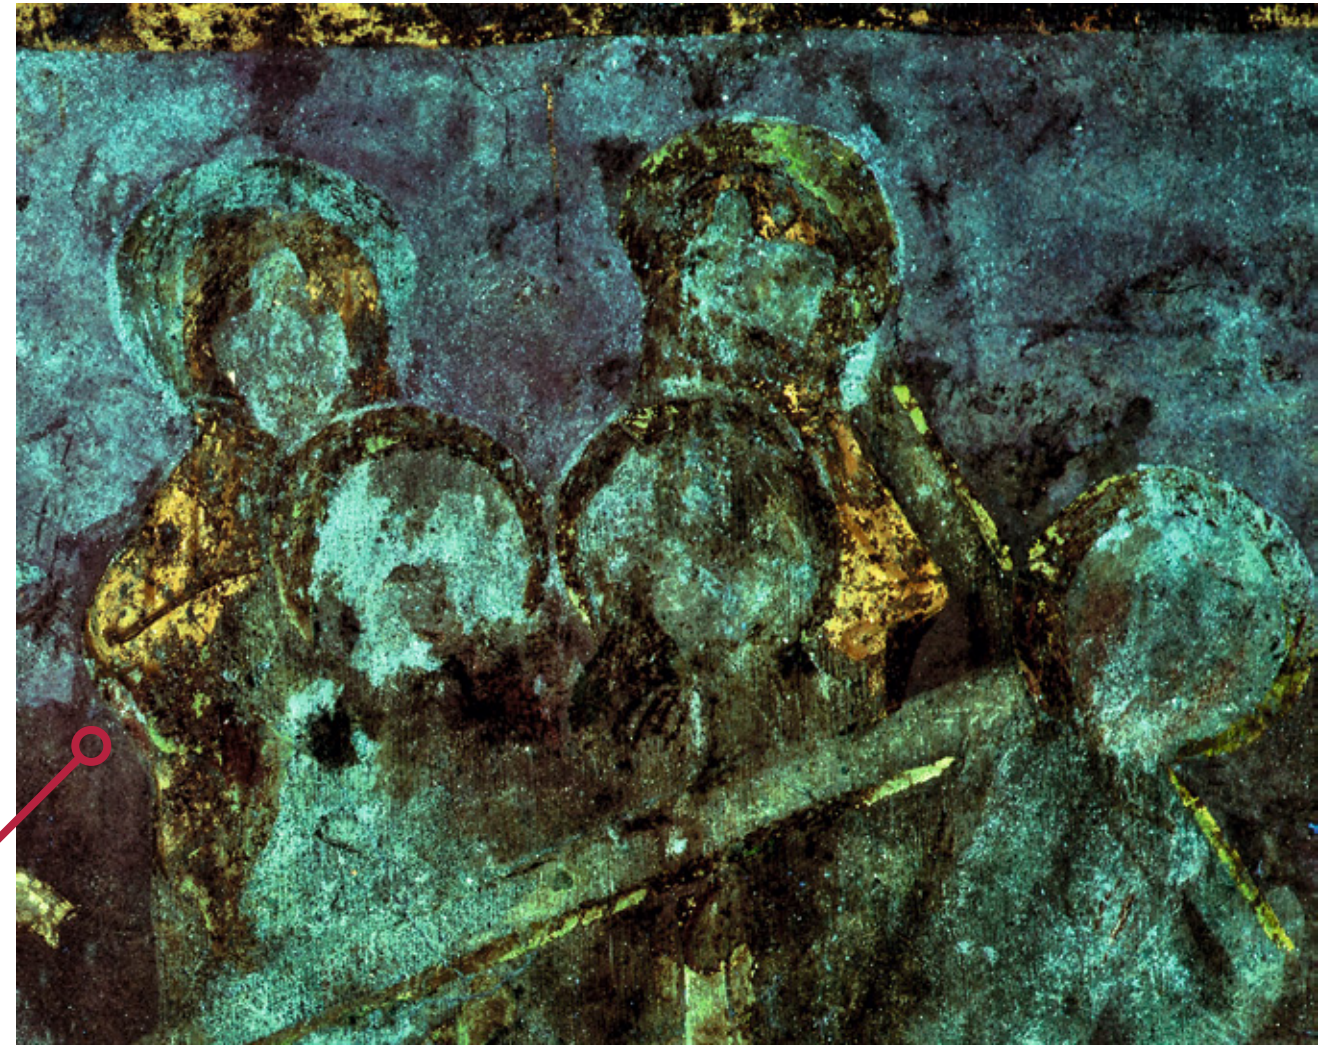
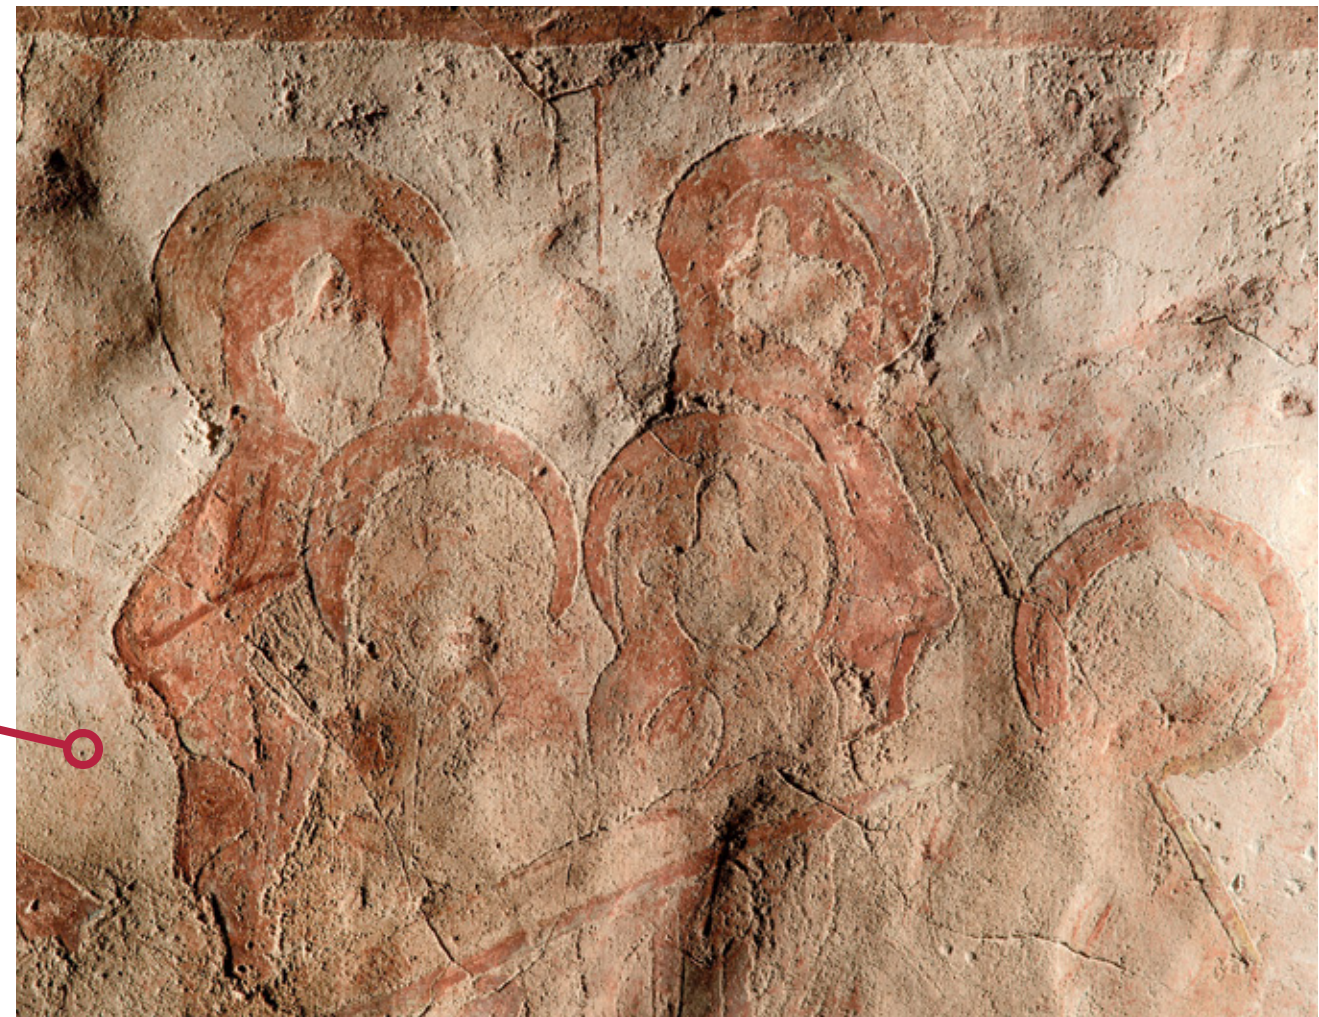
**Nerkewitz, Church of Saint George**  
 Research Project for Early Medieval  
 Mural painting in Thuringia, 2011–16.

►  
 Detail of photomap 1:10.

►►  
 Above: Detail of photomap  
 UV-fluorescence image.  
 Below: Detail of photomap,  
 raking light image.

▼  
 Choir North Wall, plan 1:10.
